## Chapter 9

# FIRE BEHAVIOR IN WORLD TRADE CENTER 2

### 9.1 INTRODUCTION

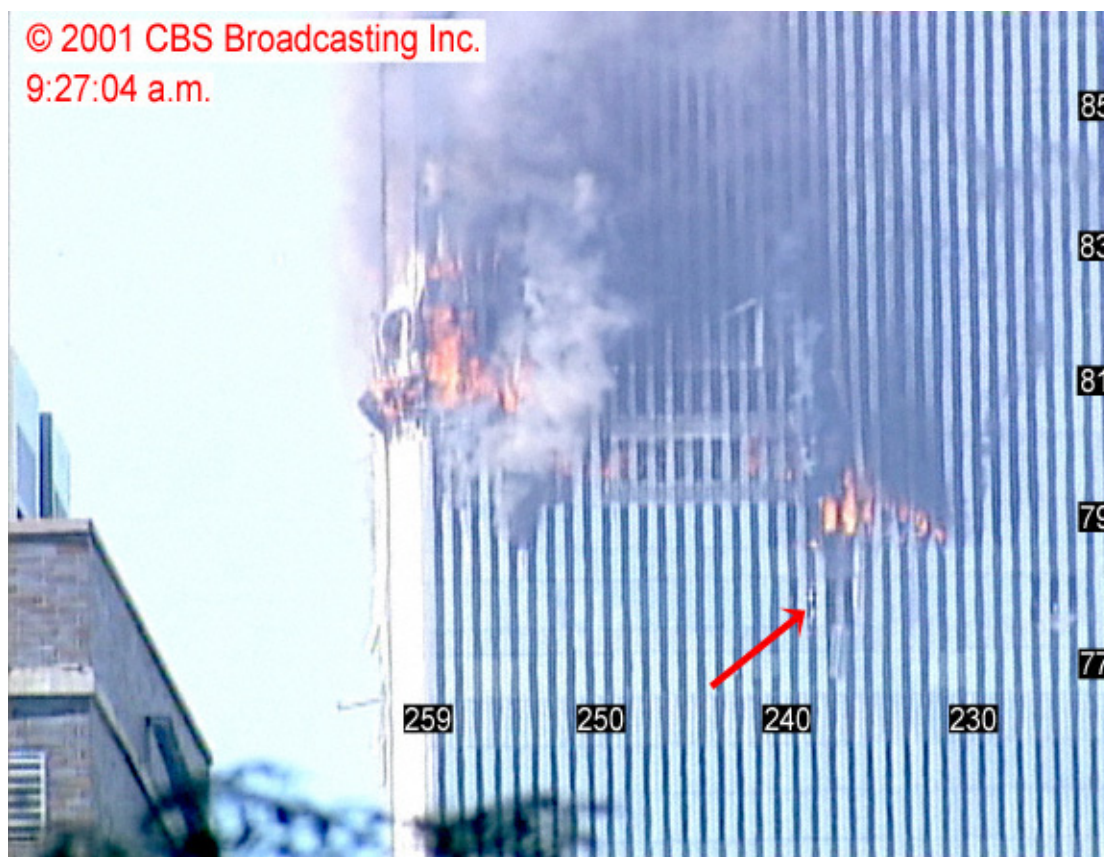
The fire burning on the 79th floor to the west of the cold spot remains in the same location and is burning with a comparable intensity to the earlier time. Flames are visible in both of the lower corners of the cold spot on the 80th floor in Figure 9–32. Due to the lower image quality of Figure 9–24, it is difficult to determine whether these flames have grown more intense during the 8 min period.

**Figure 9-32.** This captured video frame showing the north face of WTC 2 was recorded at 9:27:04 a.m. The intensity levels have been adjusted, and column and floor numbers have been added. The arrow indicates a stream of liquid-like material that was observed on the 78th floor falling in window 78-238.

There are some distinct differences between the two images. In the earlier photograph it is difficult to identify whether there is fire on the eastern edge of the 83rd floor due to the height of the flames on lower floors. At 9:27:04 a.m. fire is visible in windows 83-257 and 83-258. No other flames are visible on the north side of the 83rd floor. In the later image heavy smoke is coming from windows 79-253 and 79-254 on the 79th floor, while the area is clear in Figure 9–24. Review of videos shows that the smoke flows from these windows, as well as windows 79-257 and 79-256, were intermittent around this time and

Closer inspection of Figure 9–32 shows what appears to be a shiny silver string (indicated by a red arrow) passing from the top to the bottom of one of the windows, 78-238, on the 78th floor. In the video from which this image was taken, the material actually appeared to be a liquid pouring intermittently from the top of the window and splashing at the window base. The liquid looked as if it was glowing. It was only observed during the six seconds that this video recorded this area of the tower. In Section 9.5, a flow of similar material from windows 80-255 and 80-256 on the 80th floor of the north face will be described. It will be hypothesized that the material was most likely aluminum from the aircraft that had melted and was pouring down through an opening from the floor above. This is also a plausible explanation for the current observation. If correct, it suggests that the pile of debris located on the 79th floor above this window may have contained aluminum from the aircraft. Recall that a pile of debris in this area of the 79th floor was present immediately following the aircraft impact. An intense fire had been burning on this debris since the impact that would have provided the heat necessary to melt the aluminum.

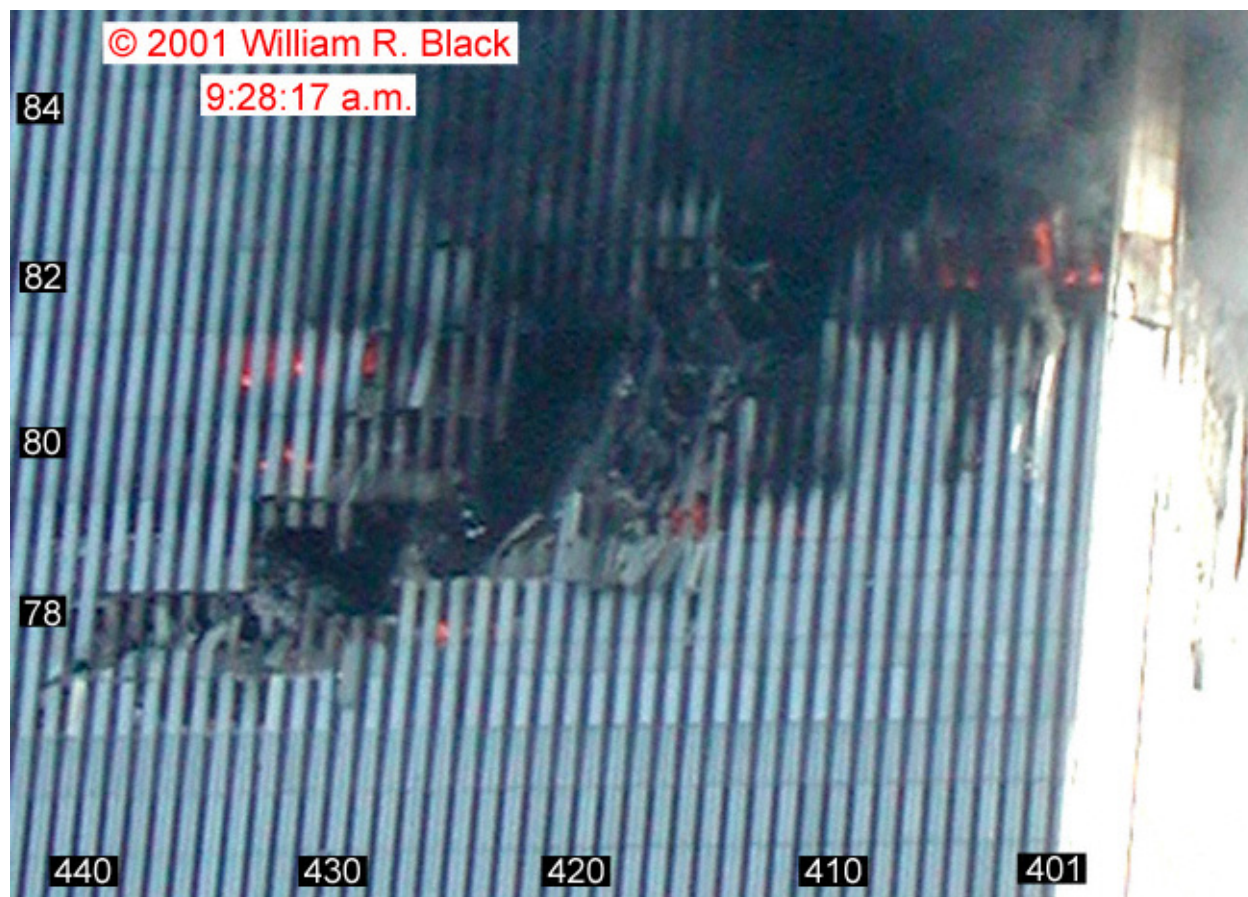
**Figure 9-33. This cropped photograph showing the south face of WTC 2 was shot at 9:28:17 a.m. The image has been rotated, and the intensity levels have been adjusted. Column and floor numbers have been added.**

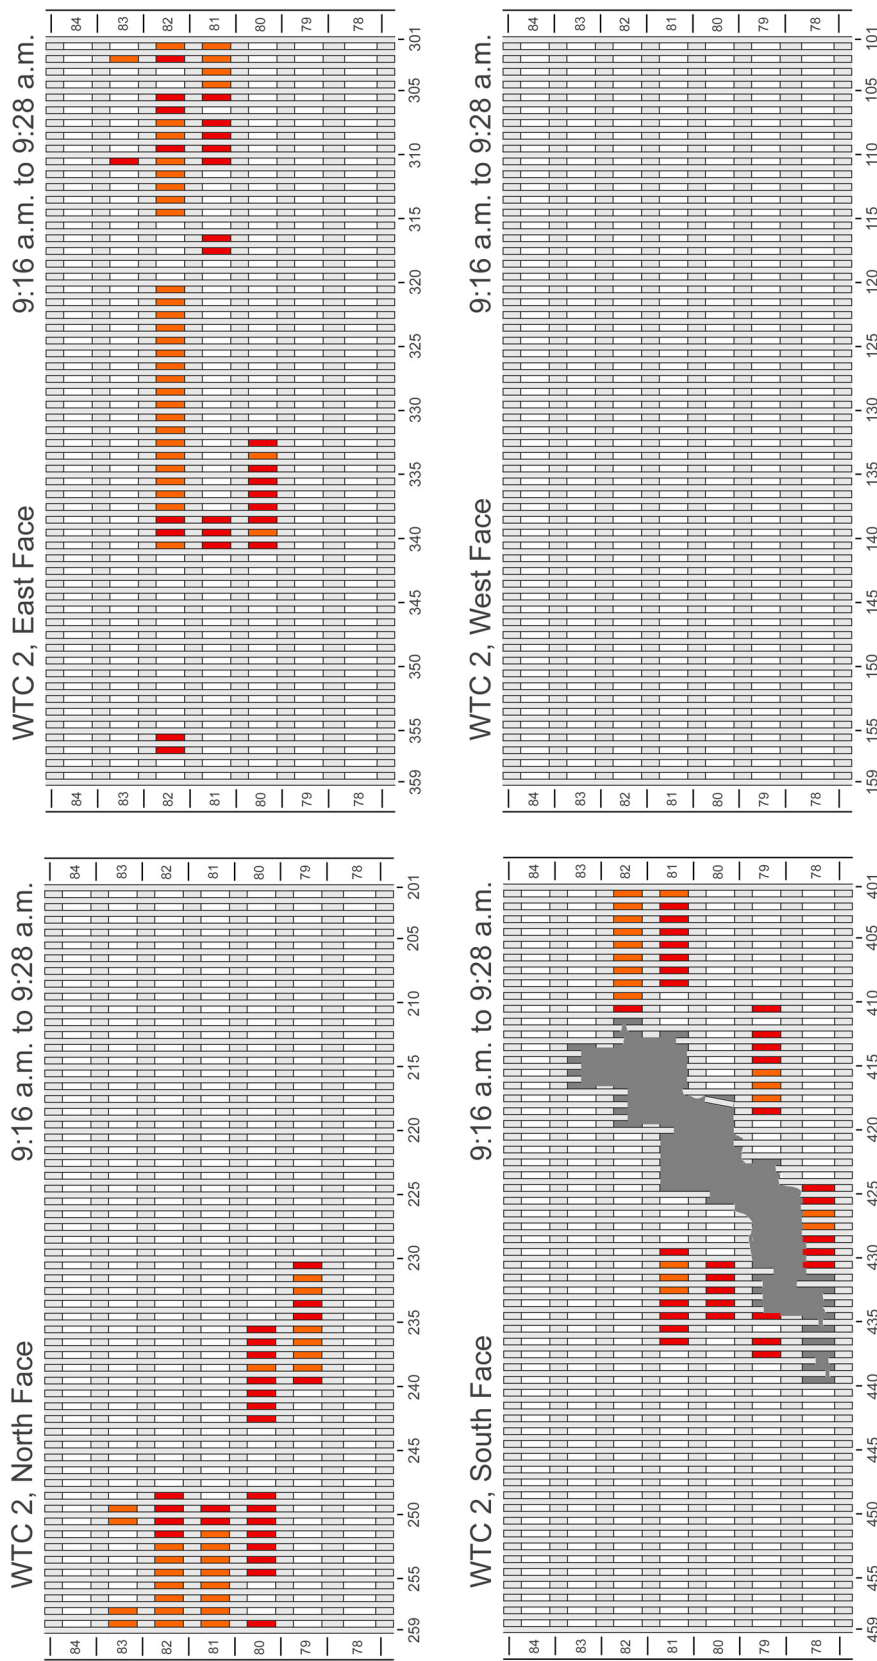
On the north face, the primary observation was the continued burning of fires on the 81st and 82nd floors on the east side of the cold spot and on the 79th floor to the west side. These fires were ignited during the aircraft impact and subsequent fireballs and appeared to be burning on piles of debris that resulted. While still substantial, these fires appeared to decrease in intensity during the period. Infrared images recorded near the start of the period confirmed that temperatures in the cold spot on the north face were near ambient. While some fires were observed at various corners of the rectangular cold spot, in general, the area remained smoke and fire free. Near the end of the period, flames were observed in windows near the east side of the 83rd floor. The appearance and positions of the numerous hanging objects visible through open windows on the north face, some of which may be floor slabs that have dropped down from the floor above, did not change noticeably during the period.

**Figure 9-34. Maps of integrated fire observations between 9:15 a.m. and 9:29 a.m. are shown for the four faces of WTC 2. Colors represent the highest intensity fire observed in a window using the color scale defined in Figure 5-1.**

On the east face a large fire that had started on the south side of the 82nd floor spread slowly to the north, going through a cycle of initial growth to an intense burning phase, followed by decline. Fires that were ignited on piles of debris located in the northeast corners of the 81st and 82nd floors continued to burn over the period, but their intensities decreased as did the intensity of a fire burning in the opening in the northeast corner on these two floors. During the period, a substantial fire was observed briefly near the east edge of the 83rd floor. Infrared images recorded during the early part of the period indicated that there was strong heating on the 81st floor and only regions of localized heating on the 79th and 80th floors. Over the course of the period, increasingly frequent and intense intermittent bursts of smoke were observed coming from windows on several floors of the face. Rapid variations in fire distribution were also observed.

The hanging object observed through a number of open windows on the east face at the 82nd floor dropped down lower in some of the windows during the period. This allowed oblique shots to show that it appeared to be a thin, sheet-like object, providing additional support for the hypothesis that it was a portion of the 83rd floor slab hanging down from above.

Most of the fires on the south face remained localized near the aircraft impact cavity during the period. This included fires to the west of the cavity on the 79th, 80th, and 81st floors and to the east on the 78th and 79th floors. Fires already present to the east of the impact cavity on the 81st and 82nd floors did not seem to spread to the east face. During the period, the fire on the 81st floor decreased in intensity, while the fire on the 82nd floor continued to burn vigorously. Near the start of the period, a substantial fire grew on the 79th floor to the immediate east of the aircraft impact cavity and then spread slowly to the east.

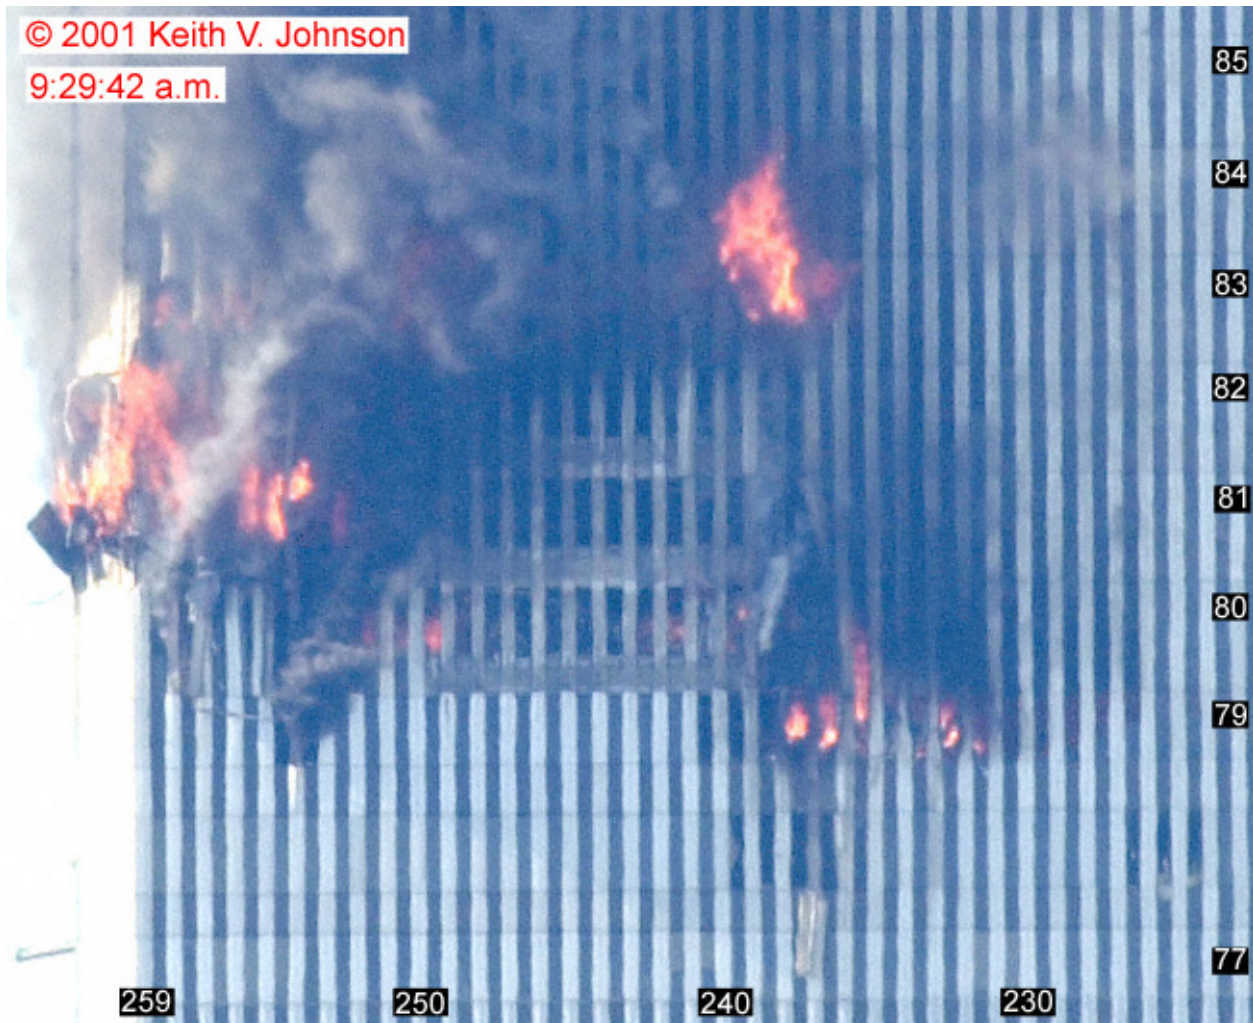
At first glance, it appears the new area of fire on the 83rd floor in Figure 9–35 is well separated from other flames on the floor. However, a dull red glow is barely visible in windows 83-240 to 83-245, suggesting there is a low intensity fire burning behind closed windows immediately above the cold spot. It seems this low intensity fire had spread further west, where it eventually broke out windows and then grew rapidly.

Comparison of Figure 9–35 with Figure 9–32, which was taken 2 min and 38 s earlier, shows how quickly the fire on the northern side of the 83rd floor grew and spread. At the earlier time there was no indication of a fire on the floor to the west of the small fires visible through windows 83-257 and 83-258. The appearance of fire at this location on the 83rd floor is the first visual evidence of significant fire spread on the north face of the tower. It took place almost 27 min after the aircraft struck the tower.

**Figure 9-35.** This cropped photograph shows the north face of WTC 2 at 9:29:42 a.m. The intensity levels have been adjusted, and column and floor numbers have been added

Elsewhere on the face, the appearance of the fires at 9:29:42 a.m. is much the same as at 9:27:04 a.m. The fires continued to burn on the debris piles at the eastern edges of the 81st and 82nd floors and closer to the center of the face on the 79th floor. The fires at the lower corners of the cold spot on the 80th floor are visible in both images. The hanging objects visible earlier in Figure 9-12 and Figure 9-16 are not immediately apparent in Figure 9-35. This is somewhat unexpected given the quality of the image.

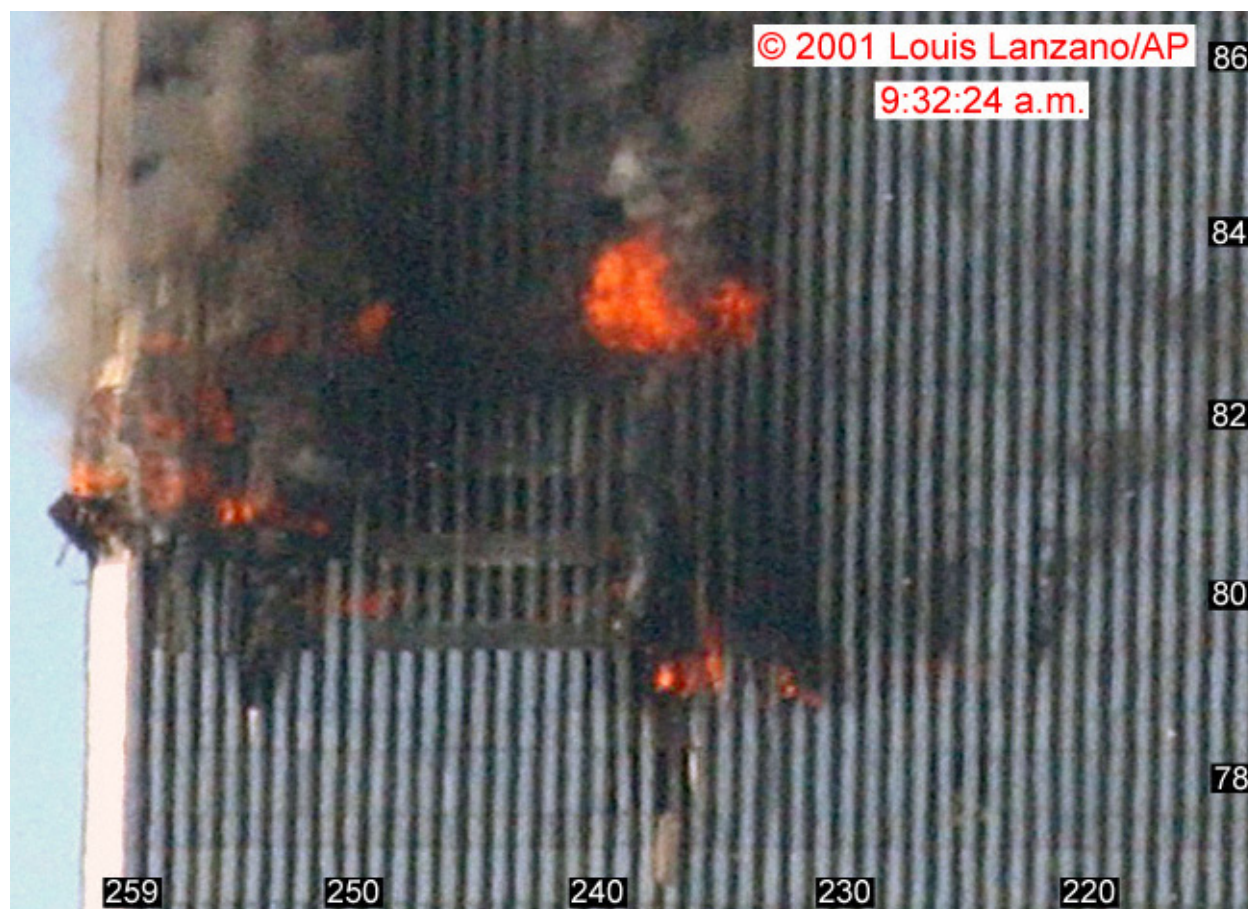
Another view of the north face taken at 9:32:24 a.m. is shown in Figure 9-36. Comparison with Figure 9-35 reveals that the intense area of fire on the 83rd floor to the west of the cold spot has spread during the 2 min and 42 s period between the times the images were taken. Long flames are now coming from a length of windows running from window 83-234 to window 83-239. Flames are also visible on this floor starting at window 93-249 and extending to the eastern edge. Flames are not visible on the floor in windows immediately above the cold spot.

**Figure 9-36. This cropped photograph shows the north face of WTC 2 at 9:32:24 a.m. The image has been rotated and enhanced by adjusting the intensities. Column and floor numbers have been added.**

Another difference between Figure 9-35 and Figure 9-36 is apparent on the 79th floor. At the later time a dull red glow is visible in windows 79-224 to 79-228, and smoke is coming from window 79-226 and window 79-222. This is evidence that the fire that has been burning on the 79th floor since the aircraft impact has begun to spread across the face toward the west.

Elsewhere on the face, the fires present in Figure 9-36 have not changed markedly for many minutes.

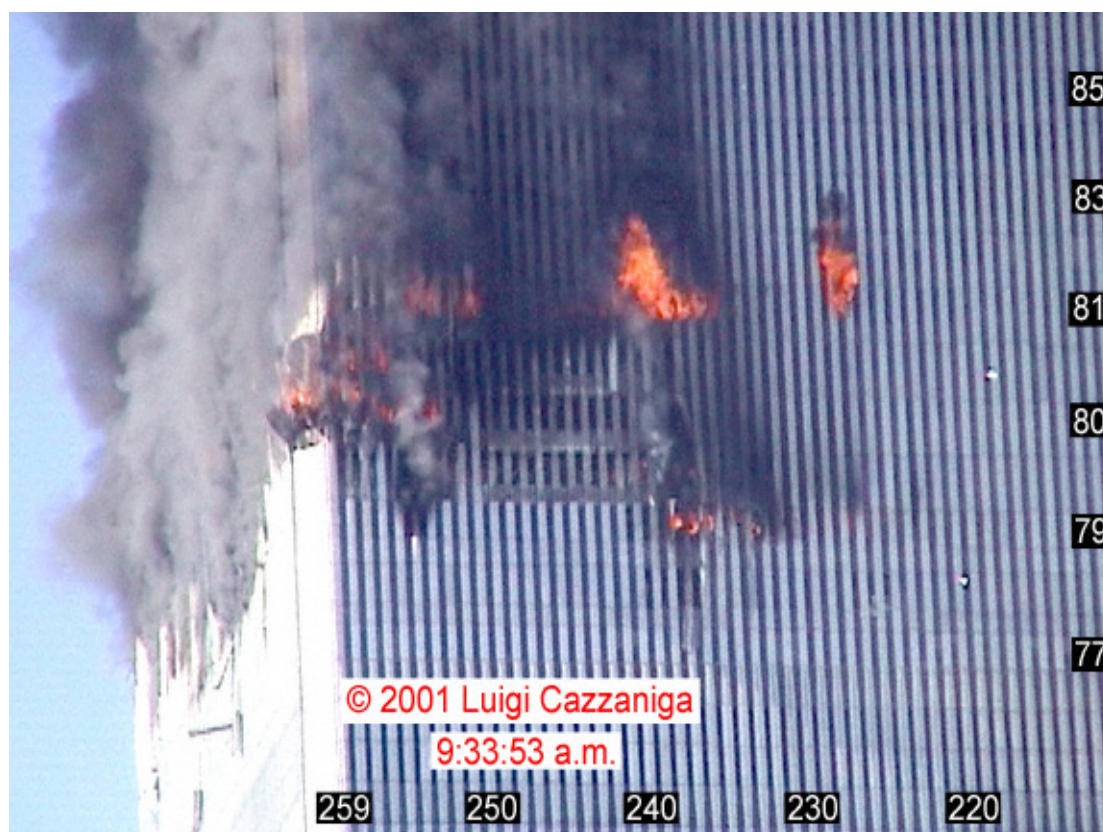
At 9:33:52 a.m. the fire burning on the 83rd floor of the north face seemed to jump several windows to the west when window 83-226 broke open, and a large flame exited. The resulting flare can be seen in Figure 9-37, which was recorded 0.9 s after the window opened. This large flame only lasted a few seconds, but after it died down heavy smoke and a shorter flame continued to come from the window.

**Figure 9-37. This frame taken from a video shows the north face of WTC 2 at 9:33:53 a.m. The intensity levels of the image have been adjusted, and column and floor numbers have been added.**

In Figure 9-37 small flames are visible in windows 83-240 to 83-244, which are located above the cold spot on the 83rd floor. This confirms that fires were present on this part of the floor. As an aside, since flames are not observed on the floor below, it also suggests that the 83rd floor slab is in place above the cold spot. The fires observed elsewhere on the face have similar distributions and intensities to those in Figure 9-32, Figure 9-35, and Figure 9-36.

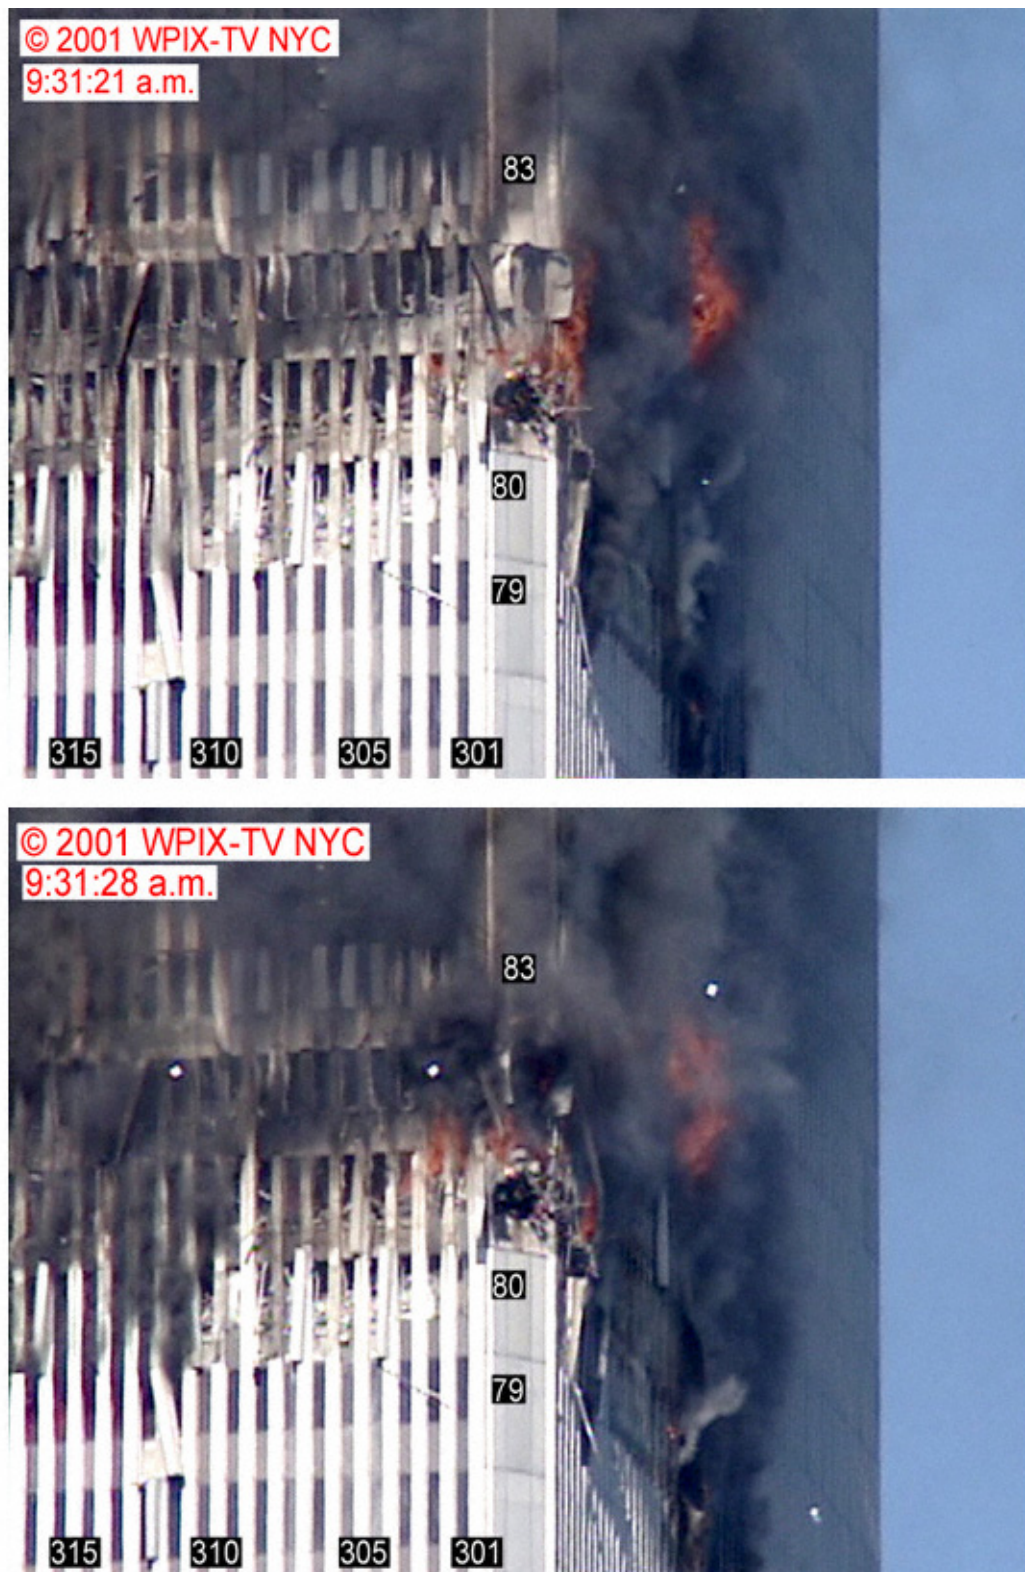
Two views of the northeast corner of WTC 2 are shown in Figure 9-38. The two images were captured from a video recording at 9:31:21 a.m. and 9:31:28 a.m. They were chosen to illustrate the appearance of the smoke puffs that had been observed periodically on the east face of WTC 2 for nearly twenty minutes. In the earlier image shown at the top of Figure 9-38, the visible portion of the east face is relatively clear of smoke. The only flame visible in windows on the east face at this time is the relatively small fire on the 81st floor in window 81-302, even though a fire continues to burn in the opening at the northeast corner of the 81st floor. Otherwise, the fires that were previously observed on this part of the east face seem to have died down. A video shot from a longer distance shows that shortly after the upper frame was recorded a smoke release occurred from multiple windows over multiple floors on the east face. This particular release was not as intense, i.e., less smoke was released, as others that were observed around this time.

Figure 9-38. Two frames captured from a video at 9:31:21 a.m. and 9:31:28 a.m. show the northeast corner of WTC 2. The intensity levels of the images have been adjusted, and column and floor numbers have been added.

The effects of the smoke release are evident in the lower image shown in Figure 9–38. Smoke has been pushed out of open windows on the 79th floor, i.e., windows 79-311 to 79-316, and can be seen rising above these windows. Comparison of the frames shows that the appearance of the smoke and fire in the vicinity of the burning corner on the 81st floor has also changed. Not only has smoke been pushed out of windows 81-301 and 81-302 and the opening on the northeast corner, but the fire intensity has also increased in the immediate area. Flames have been pushed out of windows 81-301 and 81-302. In the video it is clear that smoke was also pushed from windows on the 80th floor on the north side of the tower. In the lower image, this smoke appears as a white stream that has been pushed away from the building. In a video shot from a longer distance it was observed that smoke also appeared from windows on the 80th floor located on the south side of the east face. These observations suggest that the smoke puffs could be associated with pressure variations that were extensive enough to affect multiple floors and faces of the tower simultaneously. It should be noted that while the pressure variations that create the puffs may be the result of structural changes within the tower, the resulting pressure increases are likely to be much too small to have any impact on the structure.

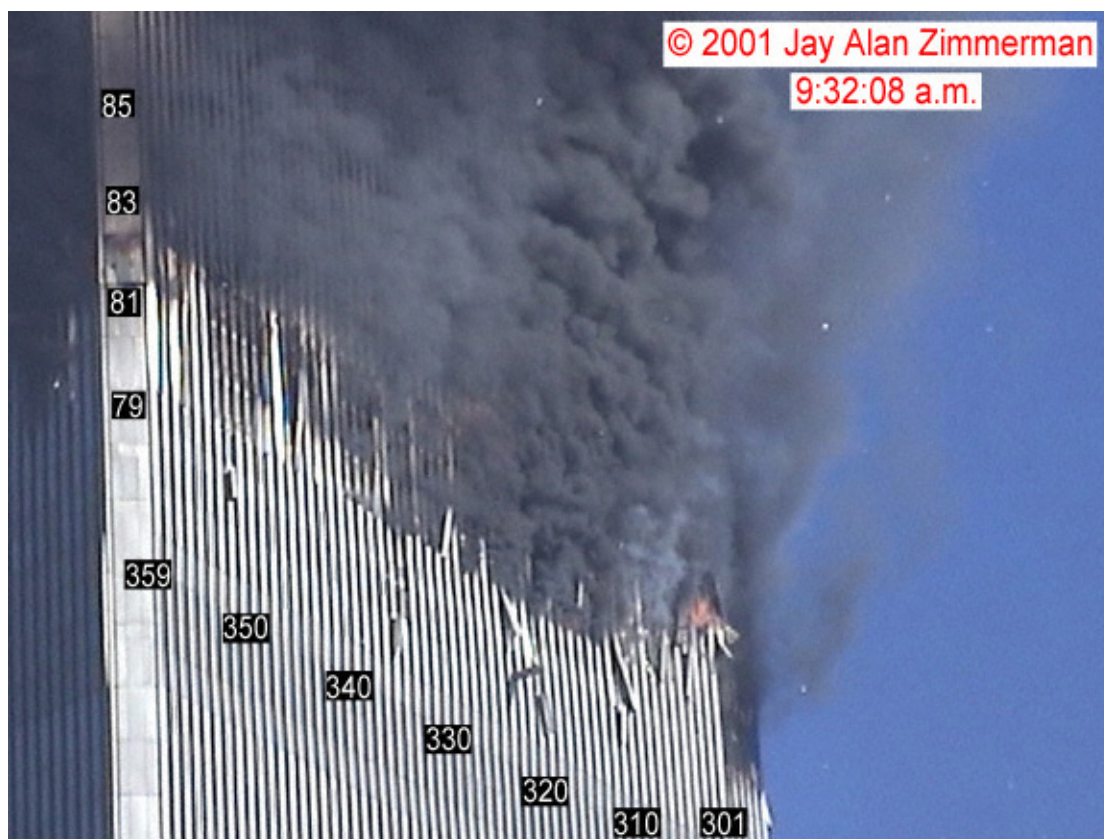
**Figure 9-39.** This view of the east face of WTC 2 is a frame from a video taken at 9:32:08 a.m. Column and floor numbers have been added. The northeast corner of WTC 1 is visible in the background.

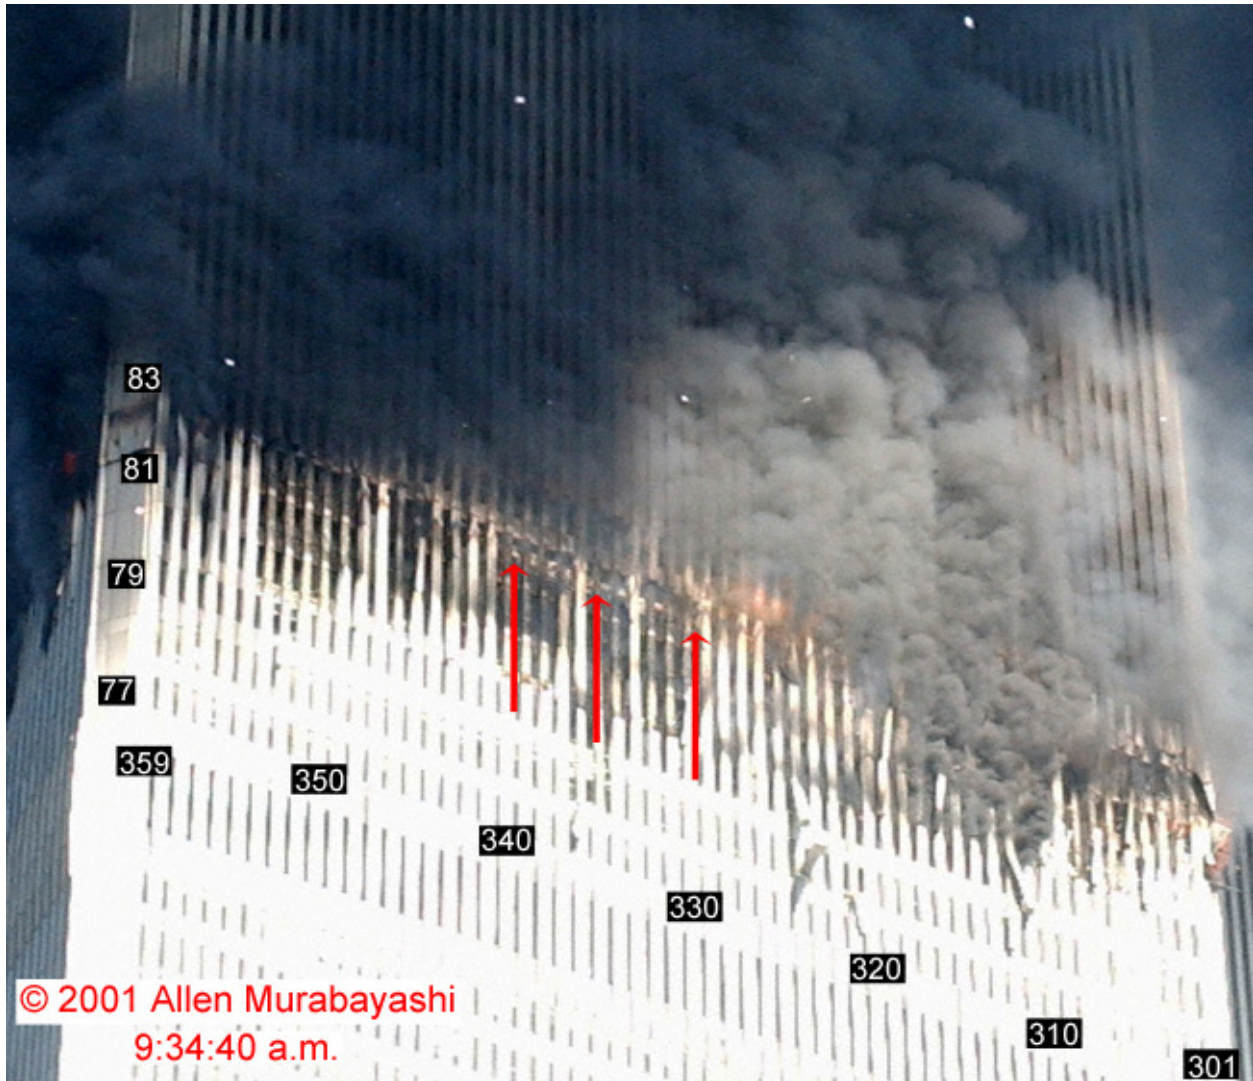
A relatively close view of the east face shot from southeast of WTC 2 at 9:34:40 a.m. is shown in Figure 9–40. This photograph was taken during a period when the flow of smoke coming from windows on the northern side of the 79th floor was fairly heavy, but when little smoke was coming from other windows below the 82nd floor. In Figure 9–27, taken at 9:25:47 a.m., windows 79-314 to 79-320 on the 79th floor had glass in place. These windows are open in Figure 9–40, suggesting that a fire must be burning nearby. The southern half of the face is visible to the tops of 83rd floor windows. Flames are

visible on the 82nd floor from window 82-322 to window 82-328. The fire on this floor has continued its spread toward the north since 9:27:35 a.m. (see Figure 9–28 and Figure 9–30 and related discussion). The fire burning in and near the northeast corner of the 81st floor is also visible in the photograph.

The arrows in Figure 9–40 indicate the hanging object that was described earlier. The appearance of the object is much the same as in Figure 9–28, which was shot from a similar angle at 9:27:35 a.m. This indicates that the portion of the object that is visible has not moved a great deal in the intervening period.

**Figure 9-40.** This cropped photograph, shot from the southeast at 9:34:40 a.m., shows the east face of WTC 2. The intensity levels have been adjusted, and column and floor numbers have been added. The arrows highlight a hanging object observed through open windows on the 82nd floor.

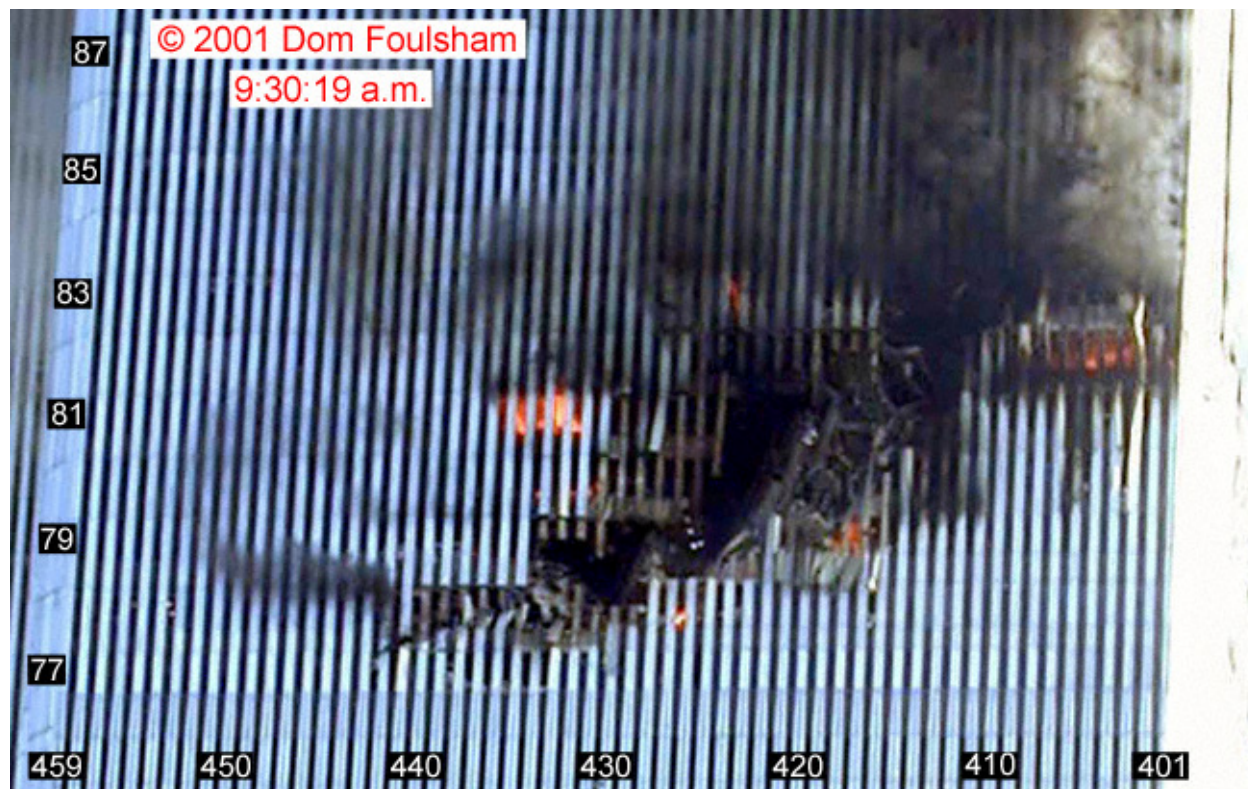
In Figure 9-41, flames are visible on the 83rd floor in window 83-424. This is the first visual evidence of a fire burning on the 83rd floor on the south face. The fire on the 82nd floor between the aircraft impact cavity and the east edge has decreased in intensity, and the smoke has cleared up since Figure 9-33 was taken. Part of the 83rd floor is now visible. It appears as if the spandrel covers at the base of this floor are missing below windows 83-401 to 83-407. There does not appear to be an active fire on this part of the 83rd floor. The small fires burning elsewhere around the aircraft impact cavity have similar appearances to those observed at the earlier time.

**Figure 9-41. This cropped photograph shows the south face of WTC 2 at 9:30:19 a.m. The image has been rotated, and column and floor numbers have been added.**

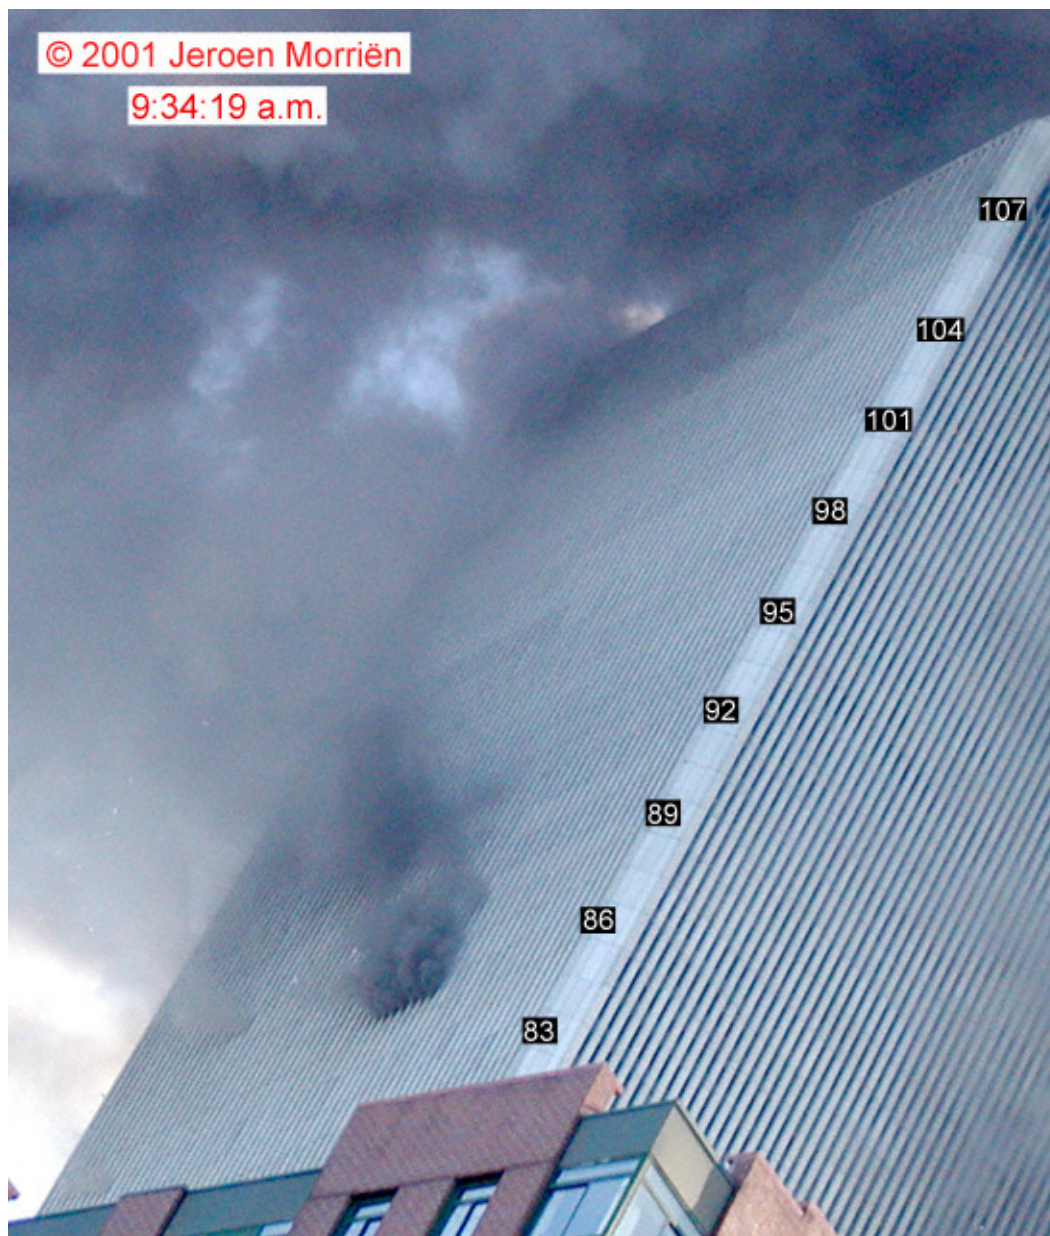
An oblique view of the west face of WTC 2 at 9:34:19 a.m. is shown in Figure 9-42. Smoke is visible at several locations on the west face. The densest smoke is flowing from windows 86-117 to 86-122 on the 86th floor. Lighter smoke is flowing from near window 88-142 and window 84-149 on the 88th and 84th floors, respectively. Smoke is also visible at two locations near the top of the tower; on the 107th floor,

where it was observed earlier, and at the top next to the southwest corner. The latter smoke flow is much lighter and is barely discernable in the photograph. In other images (not shown) it is more distinct. This smoke appears to be flowing from windows 108-101 and 108-102, which were located on the lower level of the mechanical equipment room that spanned the 108th and 109th floors. The nearest louvers to these windows are for a fresh air intake for the 107th floor observation area located opposite windows 108-101 to 108-109 (see Figure A-1 in Appendix A). This suggests that the smoke coming from the upper mechanical equipment room is back flowing through the fresh air intake for the 107th floor. Each of the locations with smoke flow on the west face is above the floors where fires have been observed, which is consistent with the possibility that people broke the glass out and released local build-ups of smoke.

**Figure 9-42.** This cropped photograph shot from the southwest shows an oblique view of the south and west faces of WTC 2 at 9:34:19 a.m. The intensity levels have been adjusted, and floor numbers have been added.

In Figure 9-42 smoke was also coming from a window, 84-149, on the 84th floor. Smoke is not visible at this location in Figure 9-57, but the image has sufficient resolution to confirm that this window was open. Windows 84-141 and 84-127 also appear to be open on this floor. It is interesting that no smoke seems to be flowing from the open windows that are located closest to the fire floors. No other open windows are apparent on lower floors (note that the image from which Figure 9-57 was cropped extended as far down as the mechanical equipment room on the 76th floor).

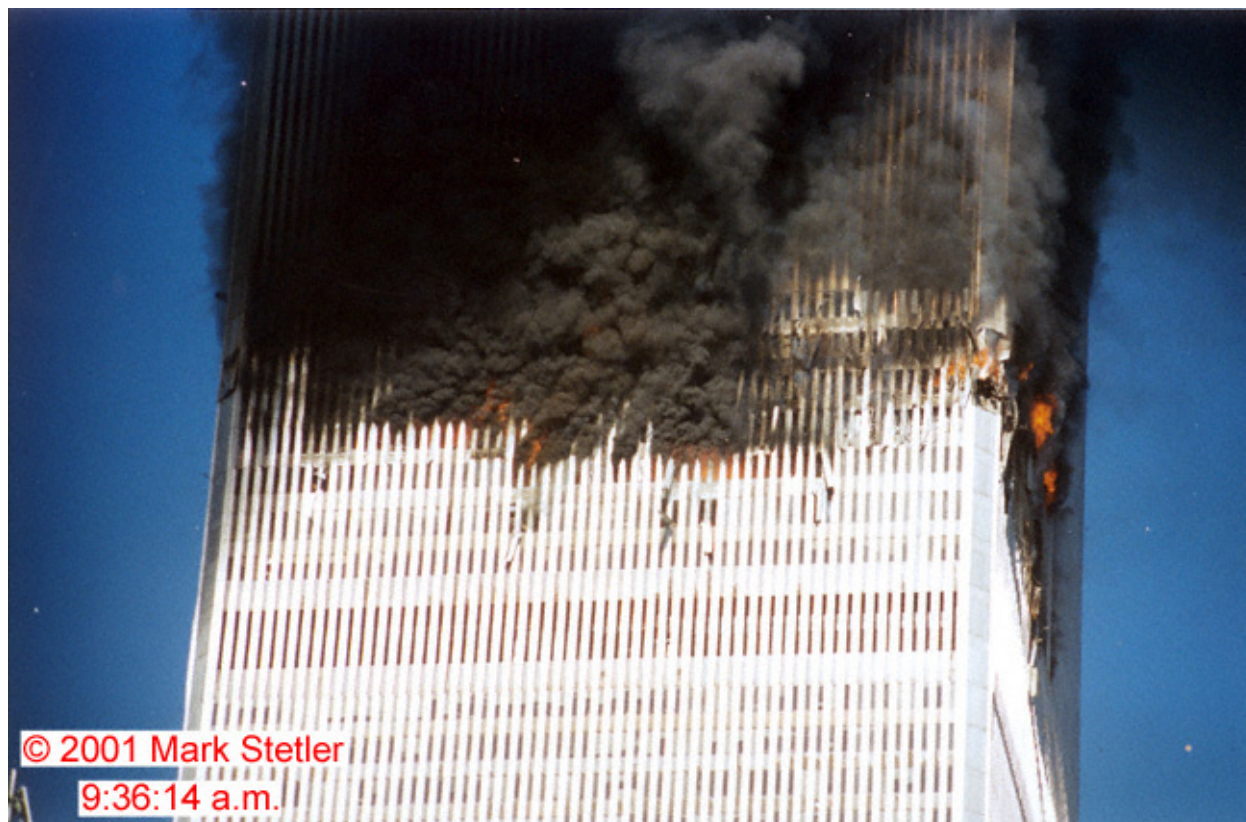
Figure 9-43 shows a photograph that was shot during this period of heavy smoke flow at 9:36:14 a.m. The northern and southern sides of the floors with smoke and fire are shown as blow-ups in Figure 9-44. The enormous increase in smoke is evident by comparing Figure 9-43 with Figure 9-40, which was shot only 1 min 34 s earlier. In the earlier photograph relatively light smoke was coming from open windows on the 79th floor roughly located between windows 79-311 and 79-317. In the later photograph smoke

flow from these windows has apparently completely halted, but now heavy smoke and fire are visible over a range of windows from window 79-318 to window 79-336. In Figure 9-44 it is apparent that smoke and, in many cases, fire are coming from every window that is open over this range. Windows 79-326, 79-329, 79-330, and 79-332 still have glass in place.

**Figure 9-43.** This photograph showing the east face of WTC 2 was taken at 9:36:14 a.m.

Heavy smoke and fire are also visible on the 80th floor from window 80-229 to window 80-249. Flames are particularly prominent in windows 80-336 to 80-343. These fires might extend over an even wider range, but many windows are hidden by smoke rising from the 79th floor. Flames are barely visible higher up on the face, which suggests that the fire on the 82nd floor continues to burn near column 330.

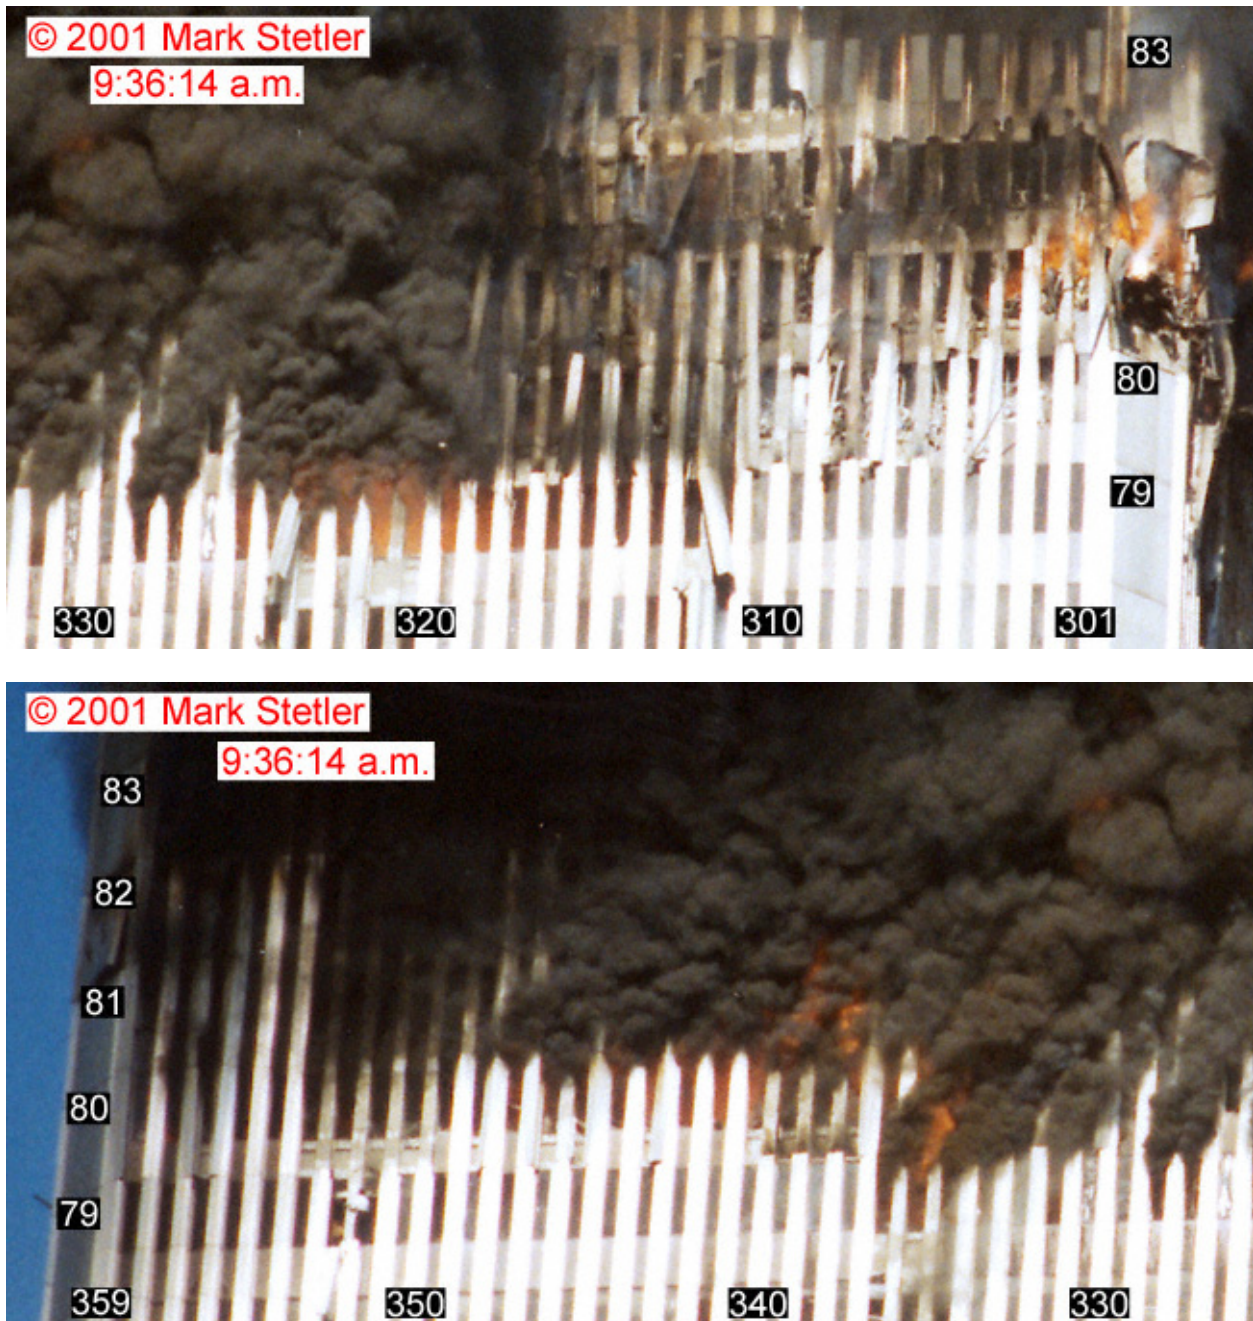
The intense fire in the northeast corner opening of the 81st floor is still present. An unusual flame is visible within this fire. In the upper photograph in Figure 9-44 a very bright white flame, as opposed to the typical yellow or orange surrounding flames, which is generating a plume of white smoke, stands out. The intensity of this flame is considerably brighter than normal flames. It was easily identified in numerous photographs and videos shot from long distances at which the surrounding “normal” flames were not visible. The brightness of the flame, along with the white smoke, suggests that some type of metal is burning. Metal combustion is known to generate much higher flame temperatures than hydrocarbon combustion, and, as a result, to burn much brighter. It is difficult to identify what type of metal is burning. Aluminum will burn, but in normal fires it usually melts instead because the metal surface is protected by an oxide layer that must be breached before ignition can take place. Aluminum oxide melts at high temperatures that are not typically reached in normal fires. There were limited quantities of other metals on the aircraft that might also burn. Whatever the metal, the ignition of a metal fire is an indication of the significant heating of the debris that took place in the northeast corner of the 81st floor due to the prolonged intense burning in this area following the aircraft impact.

**Figure 9-44.** These two images show blow-ups of the north and south sides of the east face of WTC 2 taken from the photograph included in Figure 9-43, which was shot at 9:36:14 a.m. Column and floor numbers have been added

Given the large amounts of smoke coming from the central regions of the 81st and 82nd floors on the east face, there is surprisingly little smoke at the north and south ends of these floors. With the exception of a light smoke flow from windows 78-334 and 78-335 on the 78th floor, no smoke is observed coming from below the 79th floor. Videos show that short bursts of smoke did come from other open windows on the 77th and 78th floors during the heavy smoke release.
